## **Fatigue Behavior of Dented Petroleum Pipelines — Task 4**

1 Report No <b>Task 4</b>		2. Government Accession No.		3 Recipient's Catalog No	
4 Title and Subtitle FATIGUE BEHAVIOR OF <b>DENTED</b> PETROLEUM PIPELINES (TASK 4)				5. Report Date May 1997

# **Fatigue Behavior of Dented Petroleum Pipelines**

**Final Report**

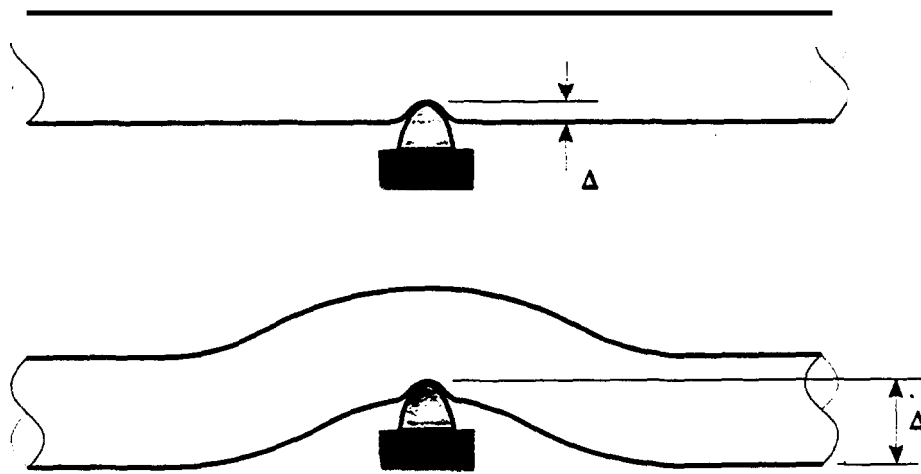
Figure 1-1: Schema of local and global bending due to pipe settlement on rock.

Rock *Damage* • Dents that form due to the pipe being laid on the rock during construction (improper bedding) or settlement of the pipe onto the rock during service. Both local and global bending stresses can result due to the settlement of the pipe (Fig. 1-1). Flexible pipe design requires the consideration of the bending stresses that develop with differential settlement along the pipe. A **uniform** settlement **will not result in** bending stresses unless the pipe settles on a rigid object such **as** a rock. In **this** case, only localized bending stresses occur in the dent region if the pipe wall is relatively flexible. Differential settlement of the pipe onto a rock or **an** increase in wall **stiffness** may result in a superposition of global bending stresses in the dented region. **This** can lead to altered fatigue behavior.

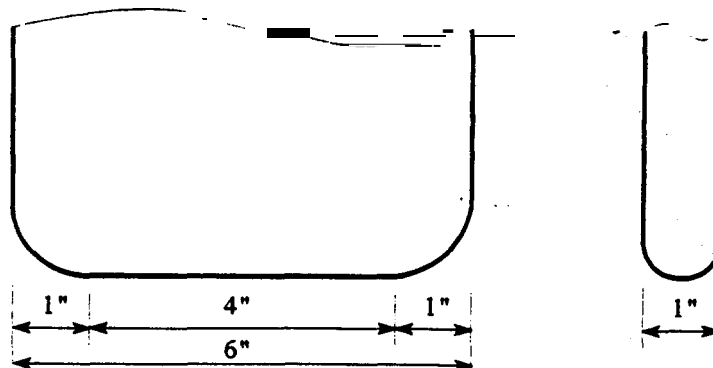
**Figure 3-1:** Indenter dimensions for **Type A** dent.

The first **type**, designated as **Type A**, **was caused by** a 6.0 in. long indenter with round edges. Figure 3-1 provides the dimension of the **Type A** indenter. **This type** of dent contained a 5-inch long machined notch in the dent **trough**, as shown in Fig. 3-2, to simulate the damage typically found in a gouge. Some of the dents were restrained on various pipes to investigate the effect on fatigue behavior.

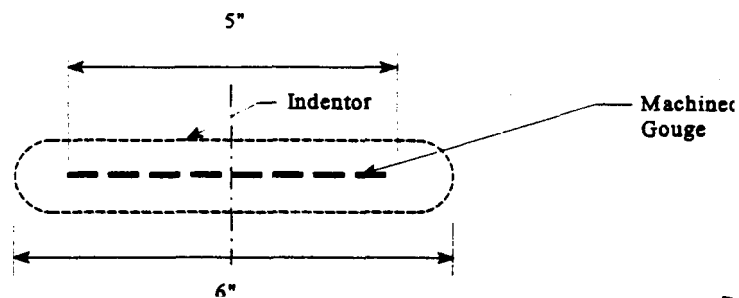
**Figure 3-2:** Gouge location for Dent **Type A**.

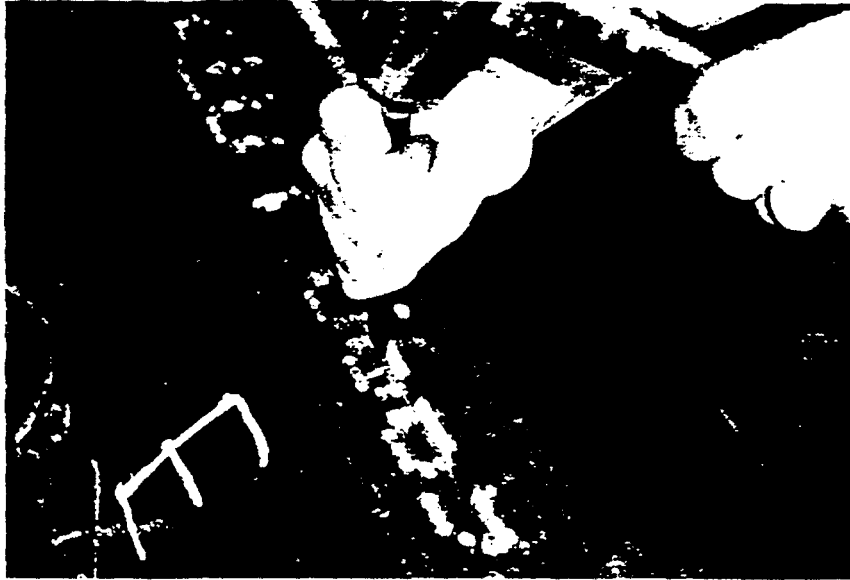
Figure 3-5: Peening of mechanical damage prior to **denting**, Specimen 4.

In an effort to reduce the severity of the machined notch, the notch in dents of several specimens were manually hammer peened as shown in Fig. 3-5, 6. Preliminary analysis of the data indicates that the peening did not significantly affect the fatigue behavior of the Type A dents. For later specimens, a scratch was formed by manually scribing a shallow notch with a hardened steel scribe, as shown in Fig. 3-6, Three passes were made along a straight-edge for each scratch in an effort to impose some of the compressive residual stresses into the gouge that would be expected if a sharp foreign object is drawn across the surface of the pipe. This dent

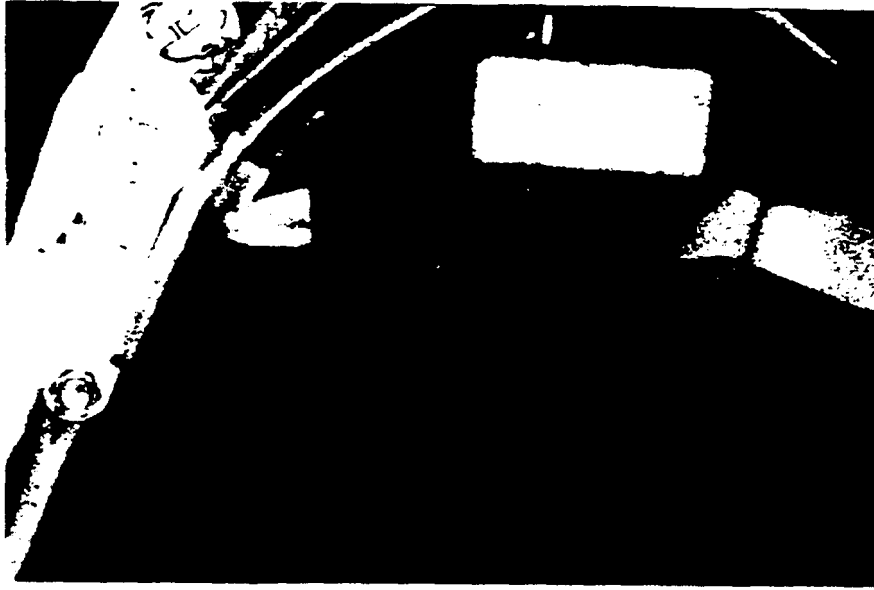
Figure 3-8: View of restrained rock, Dent F, Specimen 8.

The **third type** of **dent** investigated was the rock dent (**Type R**). **This type** of dent was formed by forcing the **rock** into the pipe wall **and** then restraining the **rock** in the same position **prior** to cyclic loading. **This allowed for** the investigation of dents **formed** by the pipeline being laid on to a rock during **initial** construction or by the settlement of the pipeline during service. Figure 3-8 provides a **view** of a **Type R** dent showing the rock restrained in a dent.

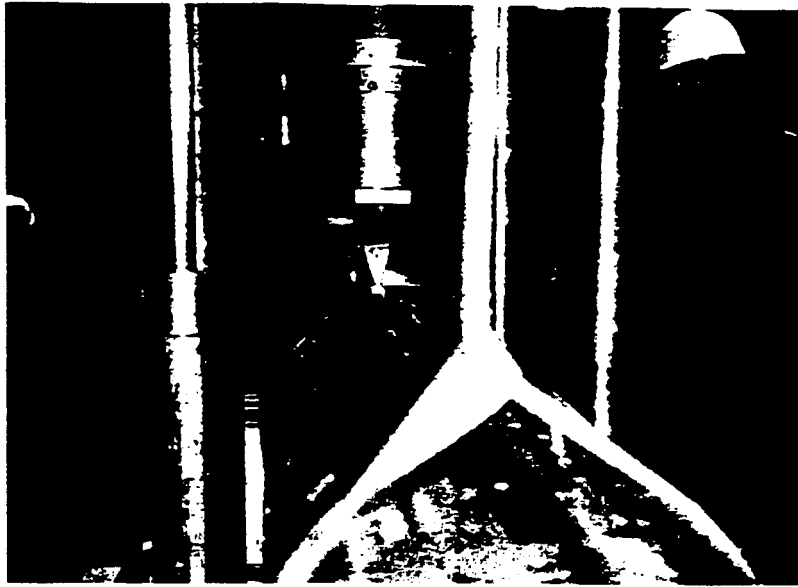
**Figure 3-9:** View of denting process in 500 kip testing apparatus, Specimen 7.

The dents were **formed** by forcing **an** indenter perpendicularly **into** the wall of each pipe specimen. **The** denting was performed in a 500 kips testing **apparatus** in the Structures Laboratory for the smaller diameter specimens (**see** Fig. 3-9) or **with** a portable load frame and actuator at **the Riverside Campus** for the **larger** diameter specimens (**see** Fig. 3-10).

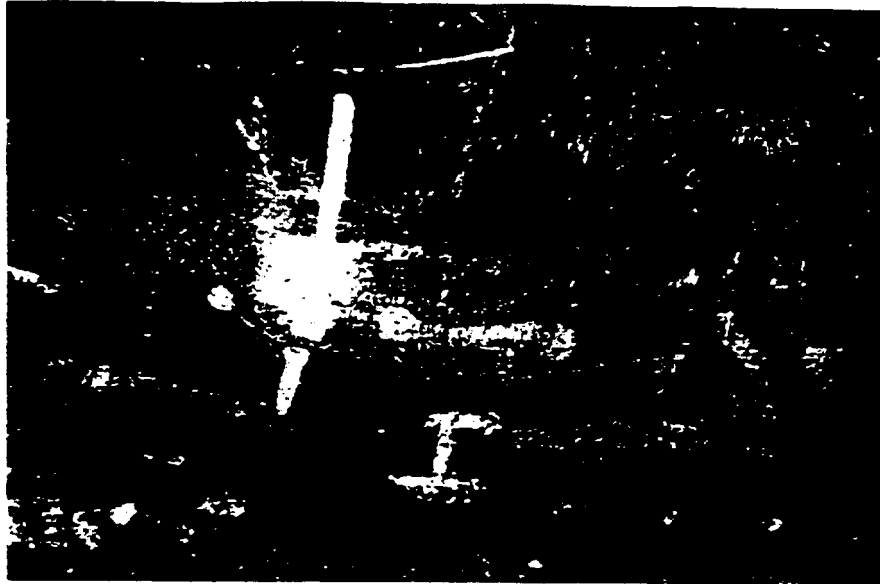
Figure 3-14: View of Dent Type **BH-L** after removal of indenter and prior to testing (Dent I. Specimen 1).

Figure 3-13 provides an example of a backhoe tooth used for the Type BH (L & T) dents. Figure 3-14 shows the same type dent after removal of the backhoe tooth. Note the impression of the backhoe tooth left in the pipe wall indicative of plastic flow and deformation. High residual stresses would be expected in this region. Consequently, fatigue crack initiation would be suppressed.

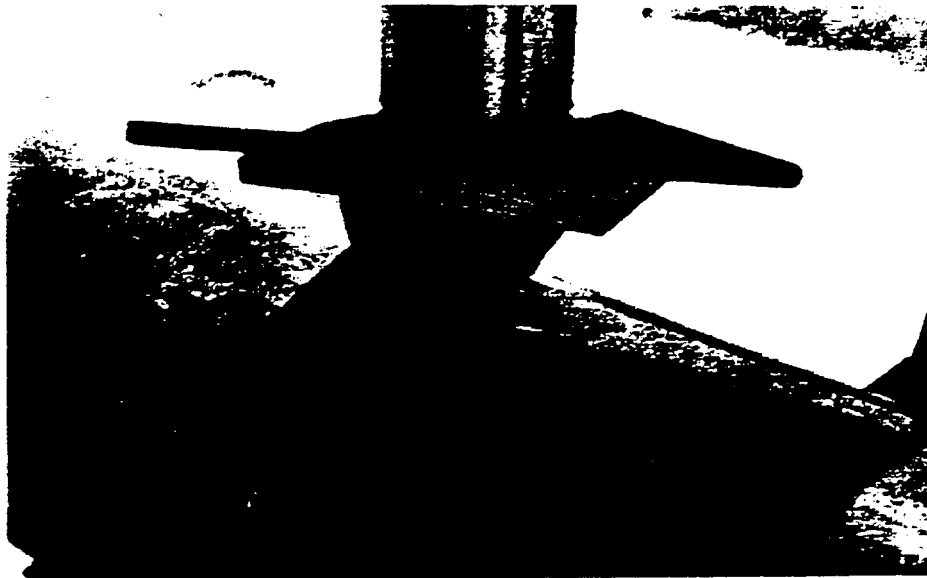
Figure 3-15: Rock indentation, Specimen 3.

The Type R dents were formed by forcing the rocks into the wall of the pipe specimens, as shown in Fig. 3-15. The same rock used as the indenter was also used during fatigue testing so the same contact forces developed at the same locations in the dent. Several of the rocks failed by tensile splitting during the denting process.

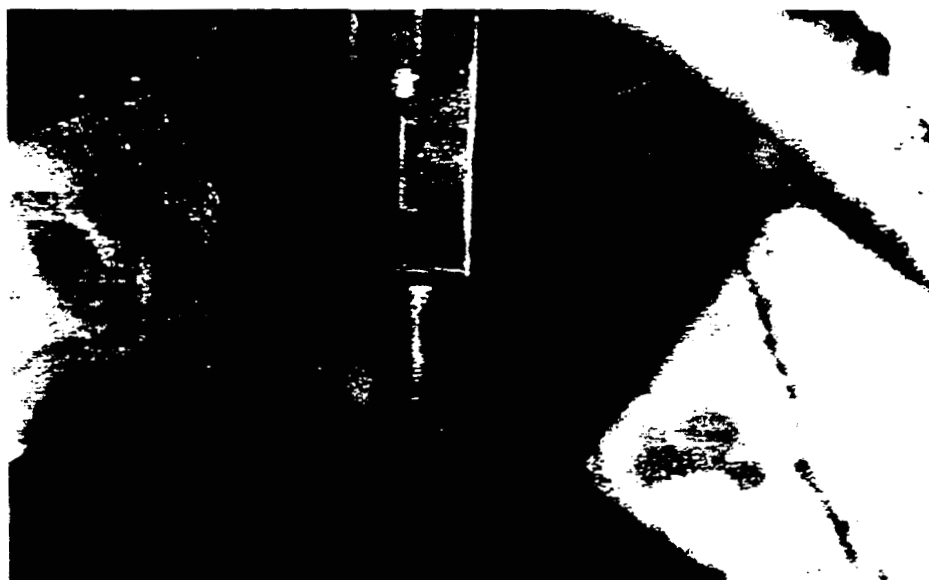
**Figure 3-18: Close up view of restrained Type A dent (Dent E, Specimen 4).**
